XYZ Building

Fire Sprinkler System

Microbiological Influenced Corrosion

Metallurgical Reference Analysis

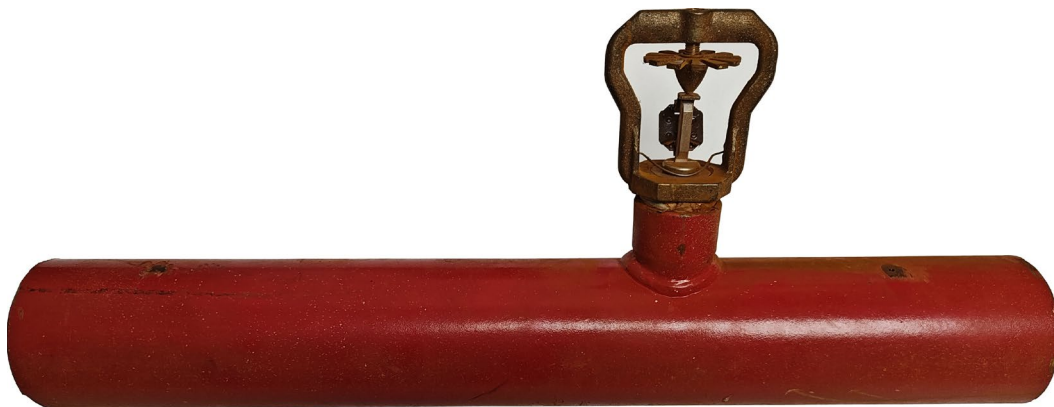
FIGURE 1: Pipe Sample as Received:

We received a section of 2.5” inch fire sprinkler pipe which was removed from the fire sprinkler system at the XYZ Building. The visual inspection of the pipe showed it to be in poor condition with corrosion debris witnessed in the bottom and upper quadrant of the inside diameter of the pipe. Where there was evidence of stagnate water that created localized corrosion. Large areas of oxygen cell corrosion were witnessed throughout the entire pipe. The purpose of this examination was to determine the overall condition of the pipe samples as well as identify the remaining wall thickness of the received sample.

2.5 Inch Schedule 10 Black Iron Pipe

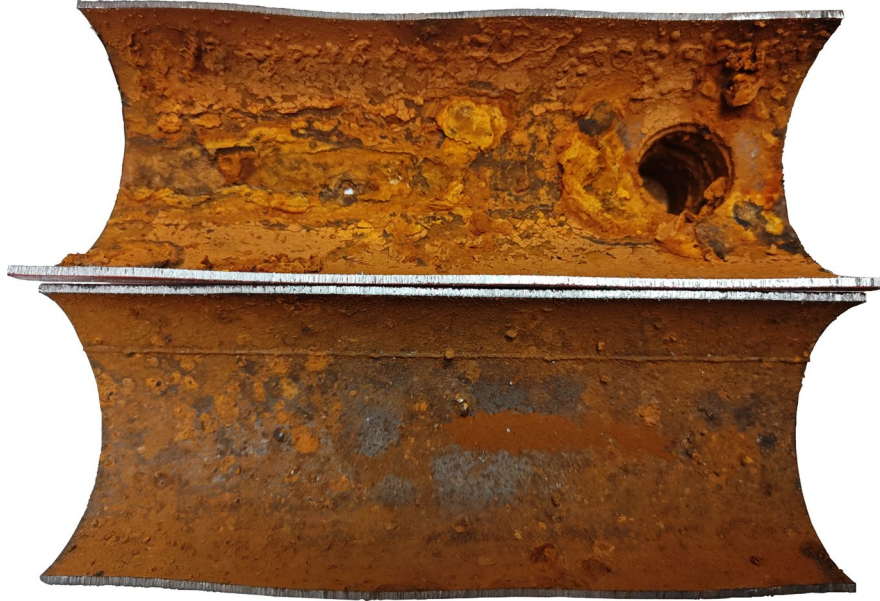
FIGURE 2; 1 Pipe Sample Sectioned: 2.5" Black Iron Schedule 10 Pipe

The visual inspection of the sample revealed very small tubercles with areas of oxygen cell corrosion pits in the location of the lower quadrant of the pipe. Mild localized pitting was witnessed in this area. The pitting is typical of pipe that has been subject to environments where stagnate water remains in wet pipe fire sprinkler system. The sample was noted as received with mild evidence of MIC and mineral related corrosion.

The as-received appearance of the submitted sample is shown. The laboratory received the pipe with no orientation identified. The pipe was marked, anticipating the 180° mark to be the top of the pipe for discussion purposes. Similarly, the bottom of the pipe was marked as the 0° position which is the location of corroded area along the bottom half of the pipe.

The pipe was then longitudinally split to allow examination of the inside diameter surface. Visual examination of the inner pipe surface disclosed the presence of reddish-brown corrosion product along the inner surface of the pipe. It was noted that significantly less corrosion was visible along the top half of the pipe. The typical appearance of this condition is shown in the figure below where the sample was sectioned to reveal the interior condition of the pipe sample.

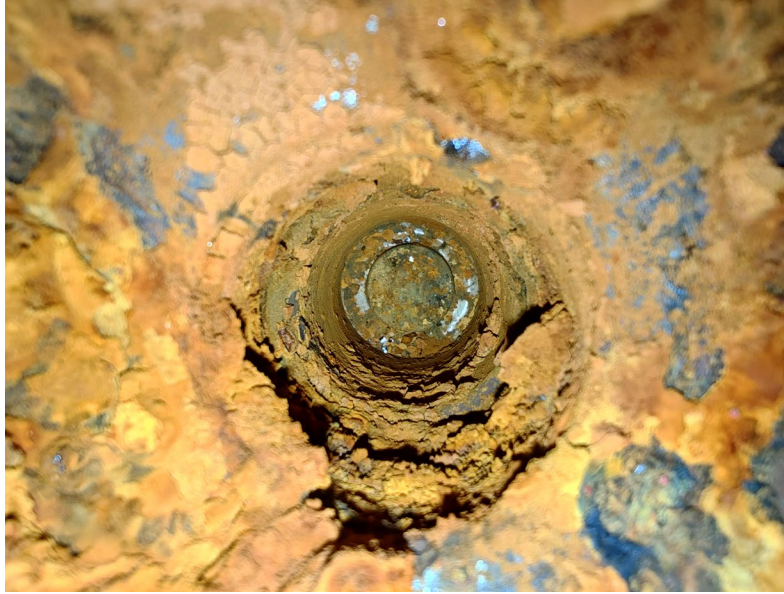
Internal Section of Pipe Clean

A section of the inside diameter surface of the pipe was then cleaned to allow further examination. Visual examination of the cleaned surface of the pipe section disclosed the presence of broad pits in the locations corresponding to the areas of localized dark reddish corrosion. The typical appearance of this condition is shown these figures.

The pictures on the next page are a sectional view of sample after being cleaned it revealed isolated small areas of pooling and generalized pitting. Further microscopic analysis was completed and is further discussed in detail later in this report. Looking at the center of the photos you will notice the etching into the pipe surface. This is typical of piping which has been compromised by both Oxygen Cell and Microbiologically Induced Corrosion. The corrosion patterns are consistent with Iron Related and Slime Producing corrosion damage.

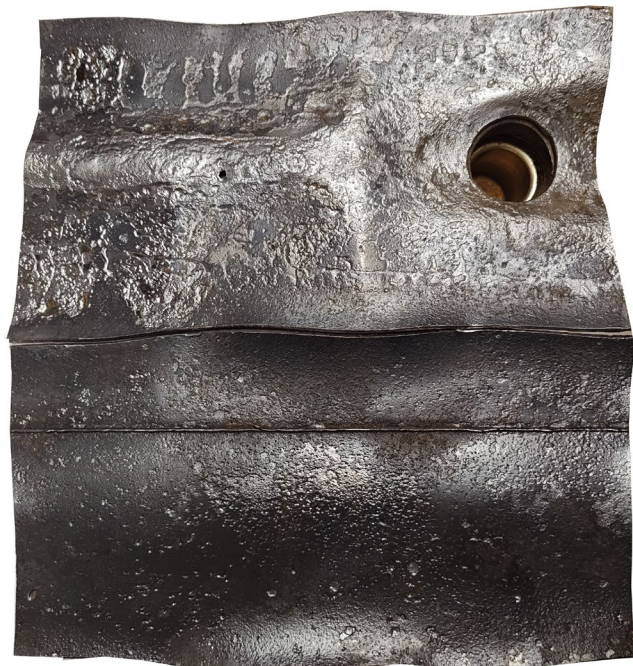
Sample 1 – 2.5 Inch Black Iron Schedule 10 Pipe Cleaned Sample Section

The surface cleaning process was completed, and the photographs revealed the samples have localized areas where pitting and wall thickness loss occurred due to processes associated with Oxygen Cell Corrosion and Acid Slime Bacteria contamination. An “Acid Slime Attack” will produce the pooling effect on the metal as seen in these samples. Acid Slime bacteria consume chlorides and sulfate minerals in the water and produce acid excretion in the process. An Iron Related Bacteria attack will produce an acidic condition that results in areas where pitting will occur, which accelerates the corrosion process from within an oxygen cell pit.

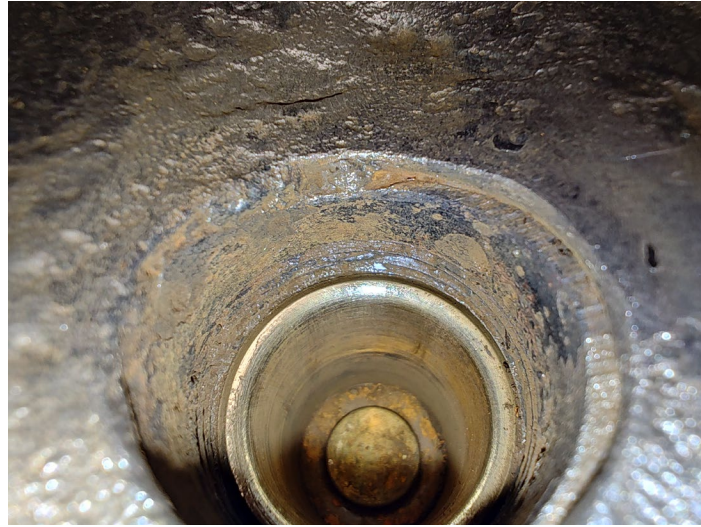
Sample 2 – 2.5 Inch Black Iron Pipe

This analysis indicates that the submitted pipe samples had experienced small pitting corrosion. Pitting is a form of generalized corrosive attack and microbiological influenced corrosion, which is associated with this breakdown. All samples received were in good condition, based on brand new pipe. The outside environment containing cold weather and snow caused this sample to begin corroding before these sample were placed in a fire sprinkler system.

The primary mechanism of the pitting appeared to be under-deposit corrosion. Under-deposit corrosion is commonly associated with oxygen pitting (oxygen cell differential). Corrosion products are initially deposited on the metal surface. These corrosion products form mounds of deposits known as tubercles. The oxygen concentration becomes depleted under the tubercles with the oxygen concentration of the bulk water remaining higher; this along with an MIC bacteria present produces the pitting seen in these photos. Additionally, corrosive species such as chlorides and sulfur compounds can concentrate under these deposits, further accelerating the corrosion rate.

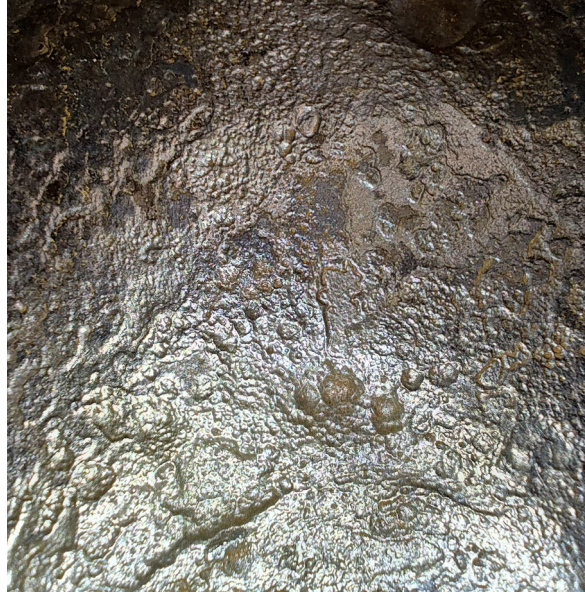
The smaller generalized acid tubercles mentioned above were observed in the perimeter surrounding the majority of the corrosion attack area and are small Oxygen Cell pits. Acid Slime bacteria function initially by consuming dissolved oxygen that was present in the water. This is one of the initial reactions that occur with oxygen cell corrosion. Once the oxygen is consumed, the reaction caused by Acid Slime bacteria reverts to an electro-chemical reaction where the Acid Slime bacteria consume chlorides and sulfate minerals in the water and produce an acid excretion in the process. The generalized reddish-brown coating on all metals is Ferrous Hydroxide. This product is the beginning process of iron migration that turns to the deep red-brown color where more oxygen can come in contact with the steel surface producing Ferric Hydroxide. An "Acid Slime Attack" will produce a pooling effect on the metal as seen in this sample. Iron Related Bacteria will produce an Acidic condition that will accelerate the corrosion process from within an oxygen cell pit.
