Tech Center

Fire Sprinkler System

Microbiological Influenced Corrosion

Re: Corporate Interiors, 3 Bottle Water Analyses

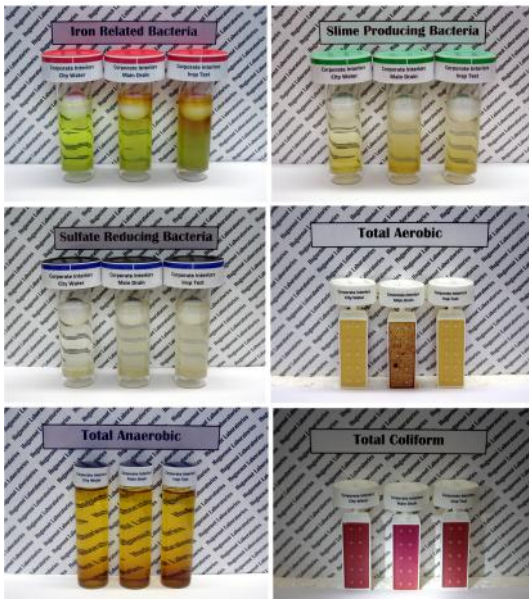
Corporate Interiors, Microbiological Influenced Corrosion Analyses

The city water sample tested negative for bacterial contamination.

The main drain sample tested positive for Total Aerobic, Coliform, Iron Related, and Slime Producing bacterium contamination.

The inspector's test sample tested positive for Iron Related, and Slime Producing bacterium contamination.

The answer to reducing or eliminating the expensive effects of the corrosion witnessed in this system requires a two-step treatment methodology. First drain the system and fill with an approved biocide and oil absorber such as FSS-ProClean B to penetrate the bio-slime mass. Allow the system to soak for 2 to 4 hours to kill all bacteria. Drain the system again to remove dirt and biological wastes then refill with our proven and approved FSS-ProGuard Copper environmentally friendly corrosion inhibitor and our FSS-BioGuard B bio-static environmentally friendly MIC controller specifically designed for fire sprinkler systems.

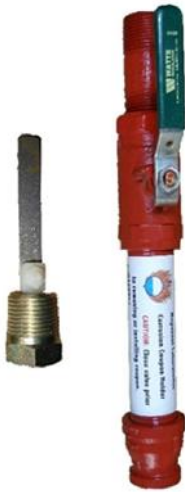
One of the most proven methods of testing corrosion potential is with corrosion coupons. The American Society of Corrosion Engineers has developed test method ASTM-G4-84 specifically testing iron pipes in plants and building. This test reports the corrosion rates and types of corrosion. It is very cost effective and proves the effectiveness of treating. Huguenot Laboratories Inc. believes it is in the best interest of owners to test before and after treatment in order to appreciate the cost effectiveness of protecting their capital investment. This simple insertion probe is one of the many methods available which evaluate the potential of corrosion.

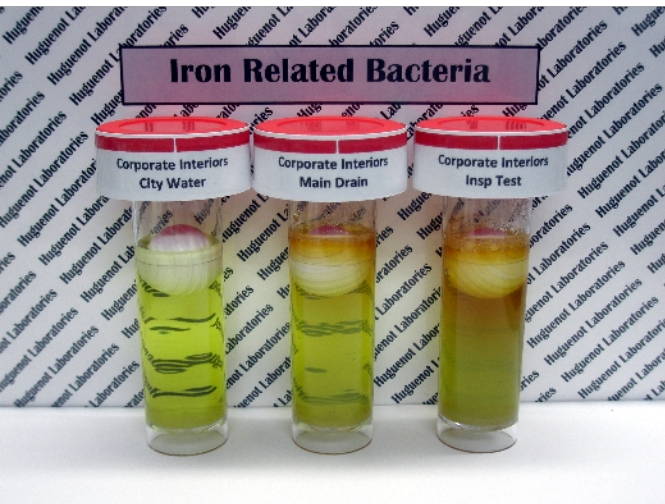
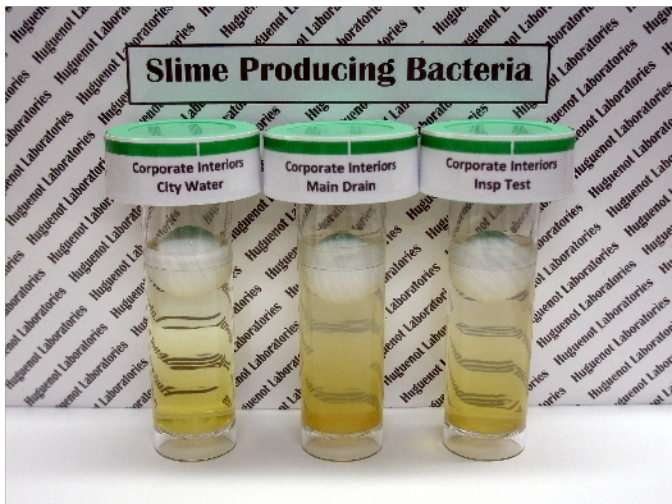
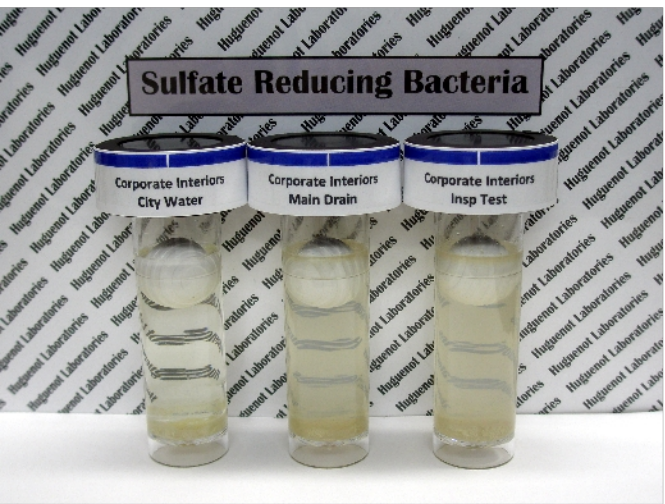
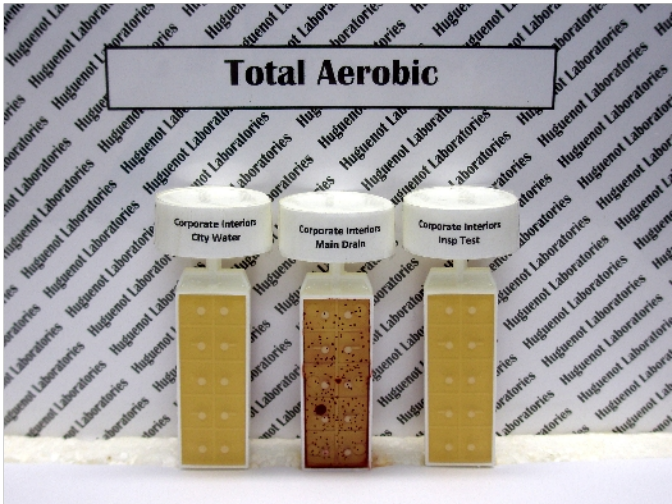
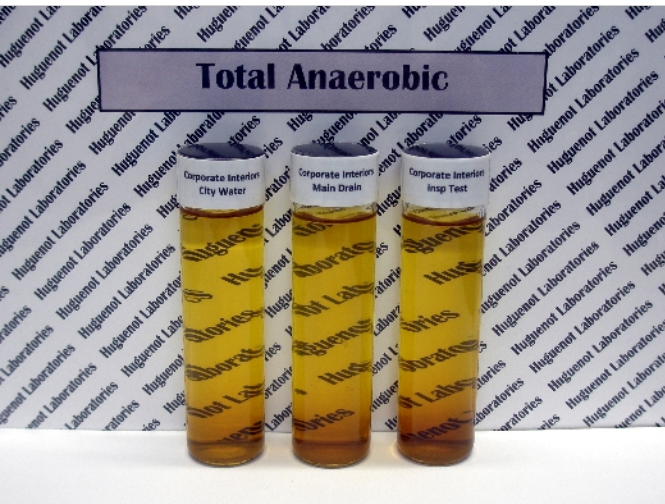
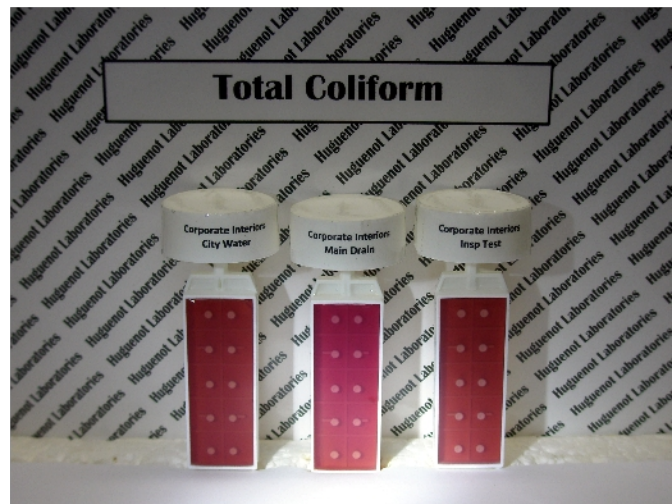
Corporate Interiors, Microbiological Influenced Corrosion Analyses

City water	Main drain	Inspector's test
Aerobic	Negative = 🟢	10,000 CFU's = 🔴	Negative = 🟢
Anaerobic	Negative = 🟢	Negative = 🟢	Negative = 🟢
Coliform	Negative = 🟢	Positive = 🔴	Negative = 🟢
Sulfate Reducing	Negative = 🟢	Negative = 🟢	Negative = 🟢
Iron Related	Negative = 🟢	140,000 CFU's = 🔴	140,000 CFU's = 🔴
Slime Producing	Negative = 🟢	1.8MM CFU's = 🔴	1.8MM CFU's = 🔴
